* 'BACK TO SCHOOL'

Disaster Preparedness and Response Workshop

Chamoli, Uttarakhand

India 2008

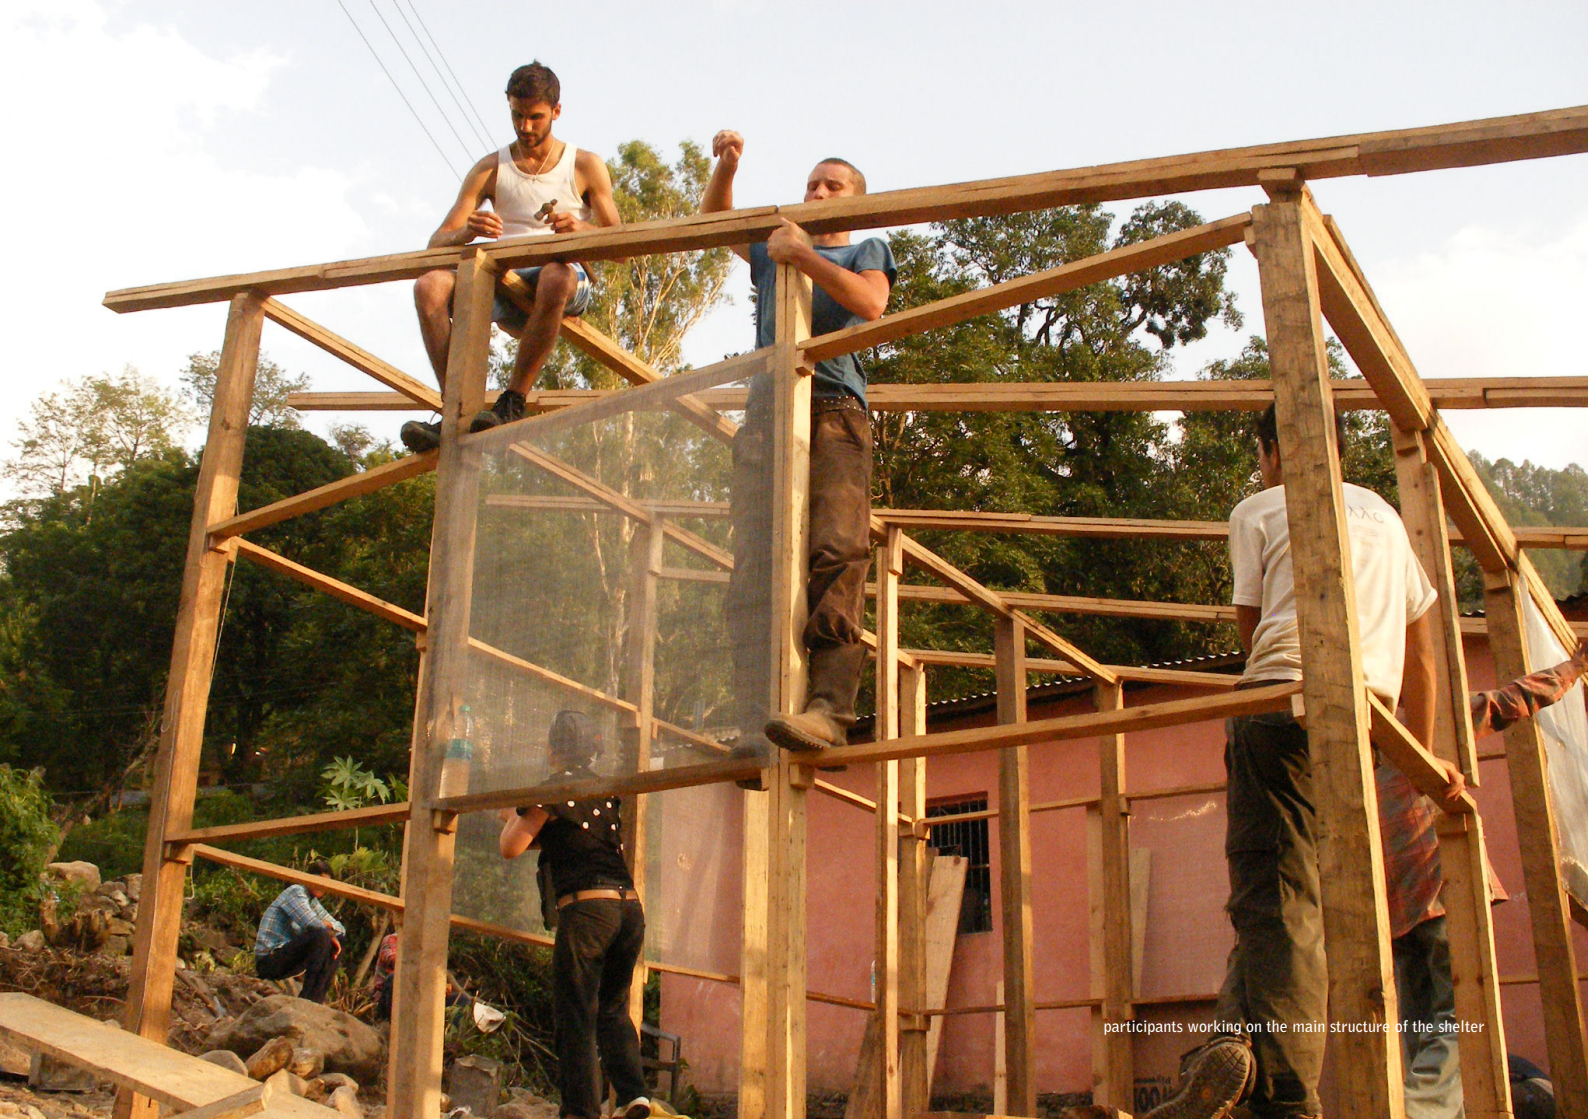
participants working on the main structure of the shelter

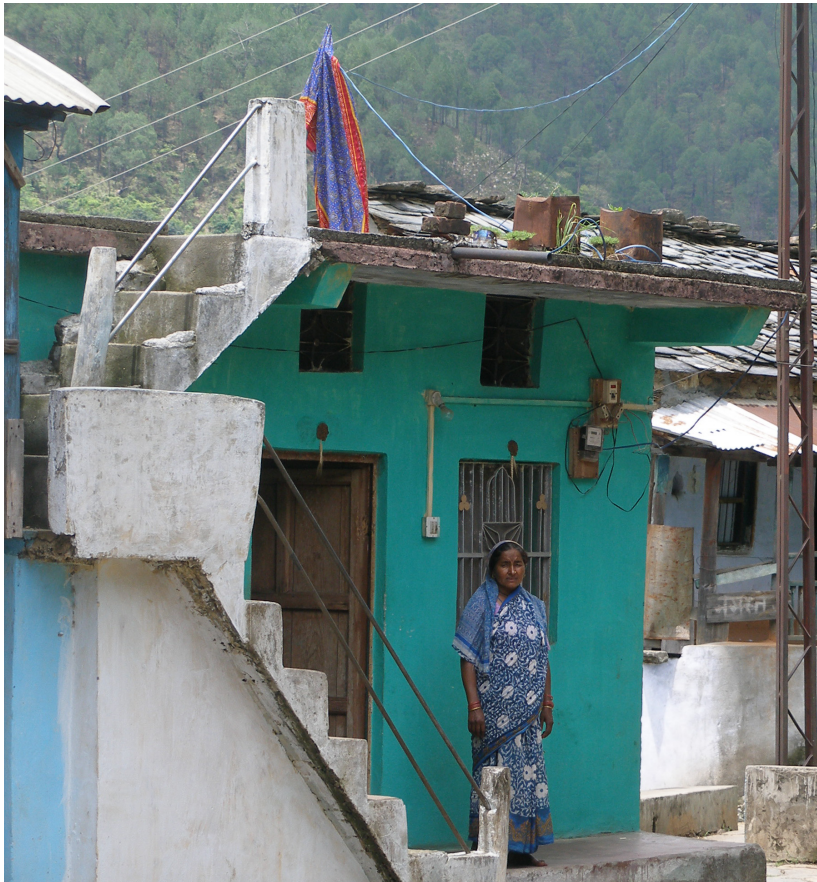
the house from the exterior showing the concrete stairs to access the roofspace

He explained that the problem with traditional construction is that the timber roof beams which rest on stone walls expand in the summer and contract in the winter causing cracking. The concrete flat roof can also be used for drying.

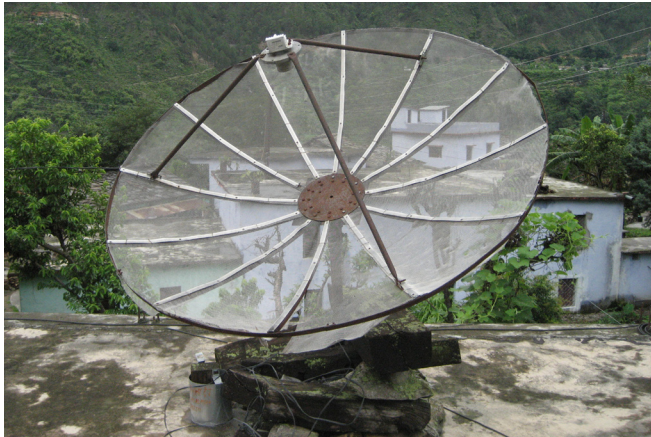
a satellite dish on the roof

This is one of the larger homes in the village with a satellite dish, small solar panel and anti-mosquito device on the roof.

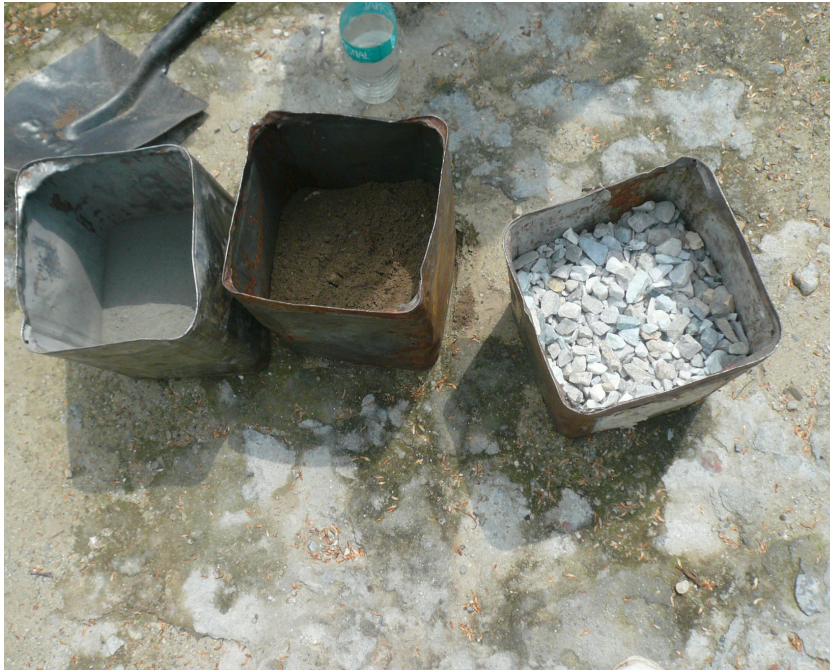
the materials used for making the concrete: cement, sand and gravel

Another main construction material for the shelter was concrete, to be used for foundations and the ground floor slab. Gravel was ordered from a local gravel pit owned by Jagdamba, located near Kaleshwar Temple. 50ft³ of gravel was ordered but only 40ft³ arrived on site after a days delay at a price of 1600 rupees. Sand was collected by the participants from the river bed; a total amount of 25ft³ was needed. The cement (12 bags) was ordered from the secretary of the school, Khatri, who also owned a local hardware shop.

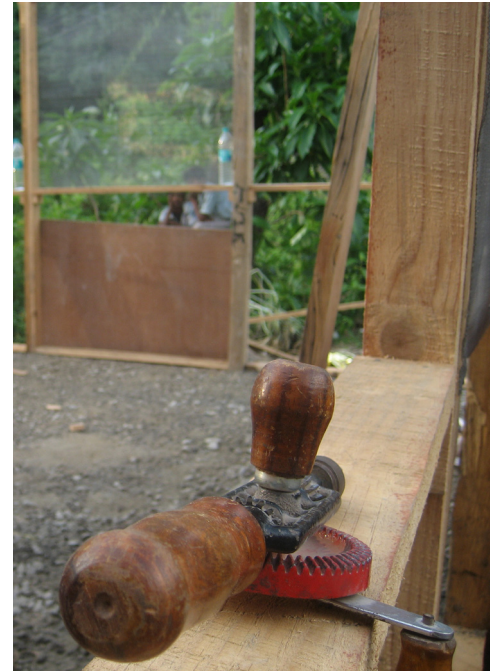
the hand-drill used for the construction of the shelter

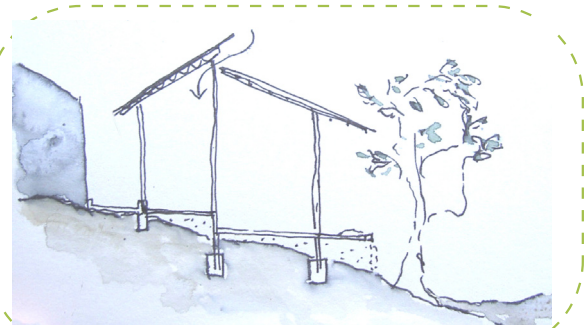
section

As shown, the conceptual design incorporates a double pitched roof, with large overhang on all sides, to protect the shelter from rain. The gap in between the two sections of roof lets light and fresh air into the shelter. A verandah provides shade and coolth, and allows for better ventilation. Prevailing wind in the area comes from the south-west, so openings are facing that direction in order to maximise ventilation.

The shelter makes use of a simple timber frame structure, which is lightweight, easily available, quick to erect and relatively cheap. In addition, two damaged steel electricity posts that were found on the way to site have been incorporated into the roof structure (see photograph on this page).

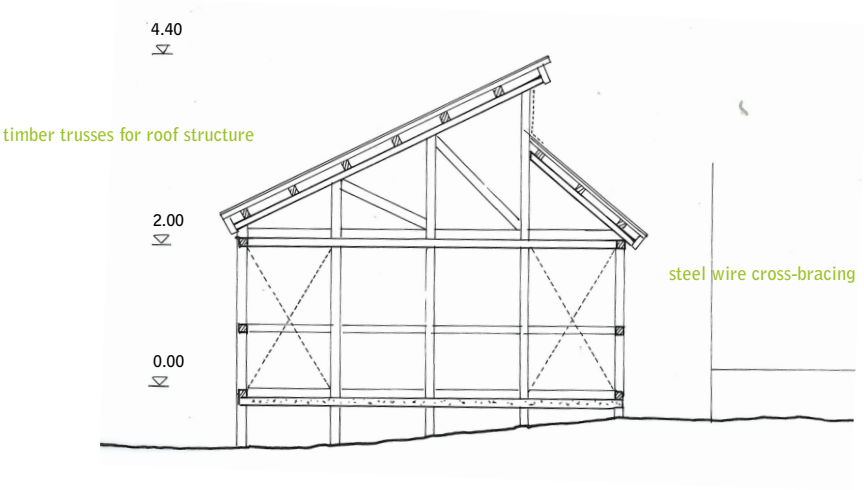
SECTION

construction drawing

Based on the conceptual design of the shelter, a series of construction drawings was developed in order to figure out dimensions, calculate how many materials were needed, and what the overall cost would be. The opening between the two roof sections has been turned 180 degrees to maximise the amount of sunlight entering the shelter. The level difference between living and sleeping space has been taken out of the design and a sleeping platform constructed for protection and extra storage. And finally, the steel roof member has been removed from the design because of ownership issues.

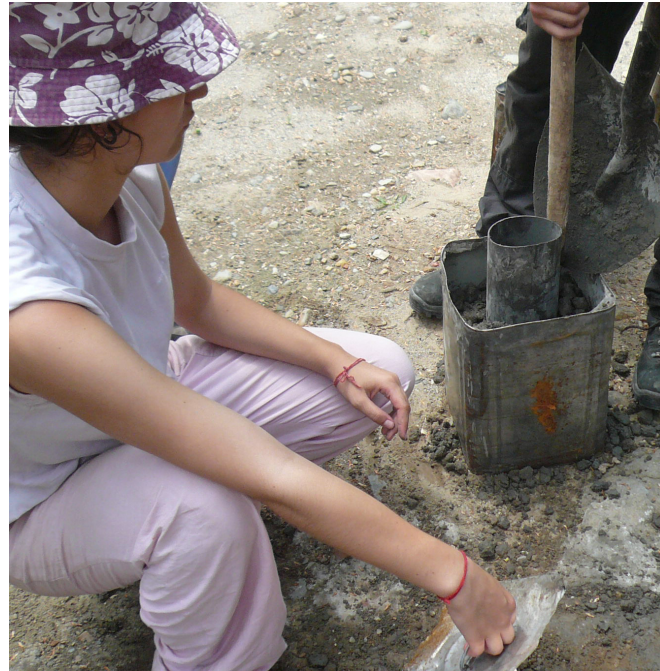
preparing the foundations

Foundations were constructed out of old oil tins that were bought off a local resident. The lid was cut off these tins, a piece of PVC pipe was inserted, and concrete was poured into the can around the pipe. Timber posts could then be inserted into the PVC pipes and were thus relatively protected from rotting. A few timber posts with a larger section were cast into concrete that was poured into holes protected with aluminium sheets since they did not fit the tin cans or PVC pipes (see picture overleaf).

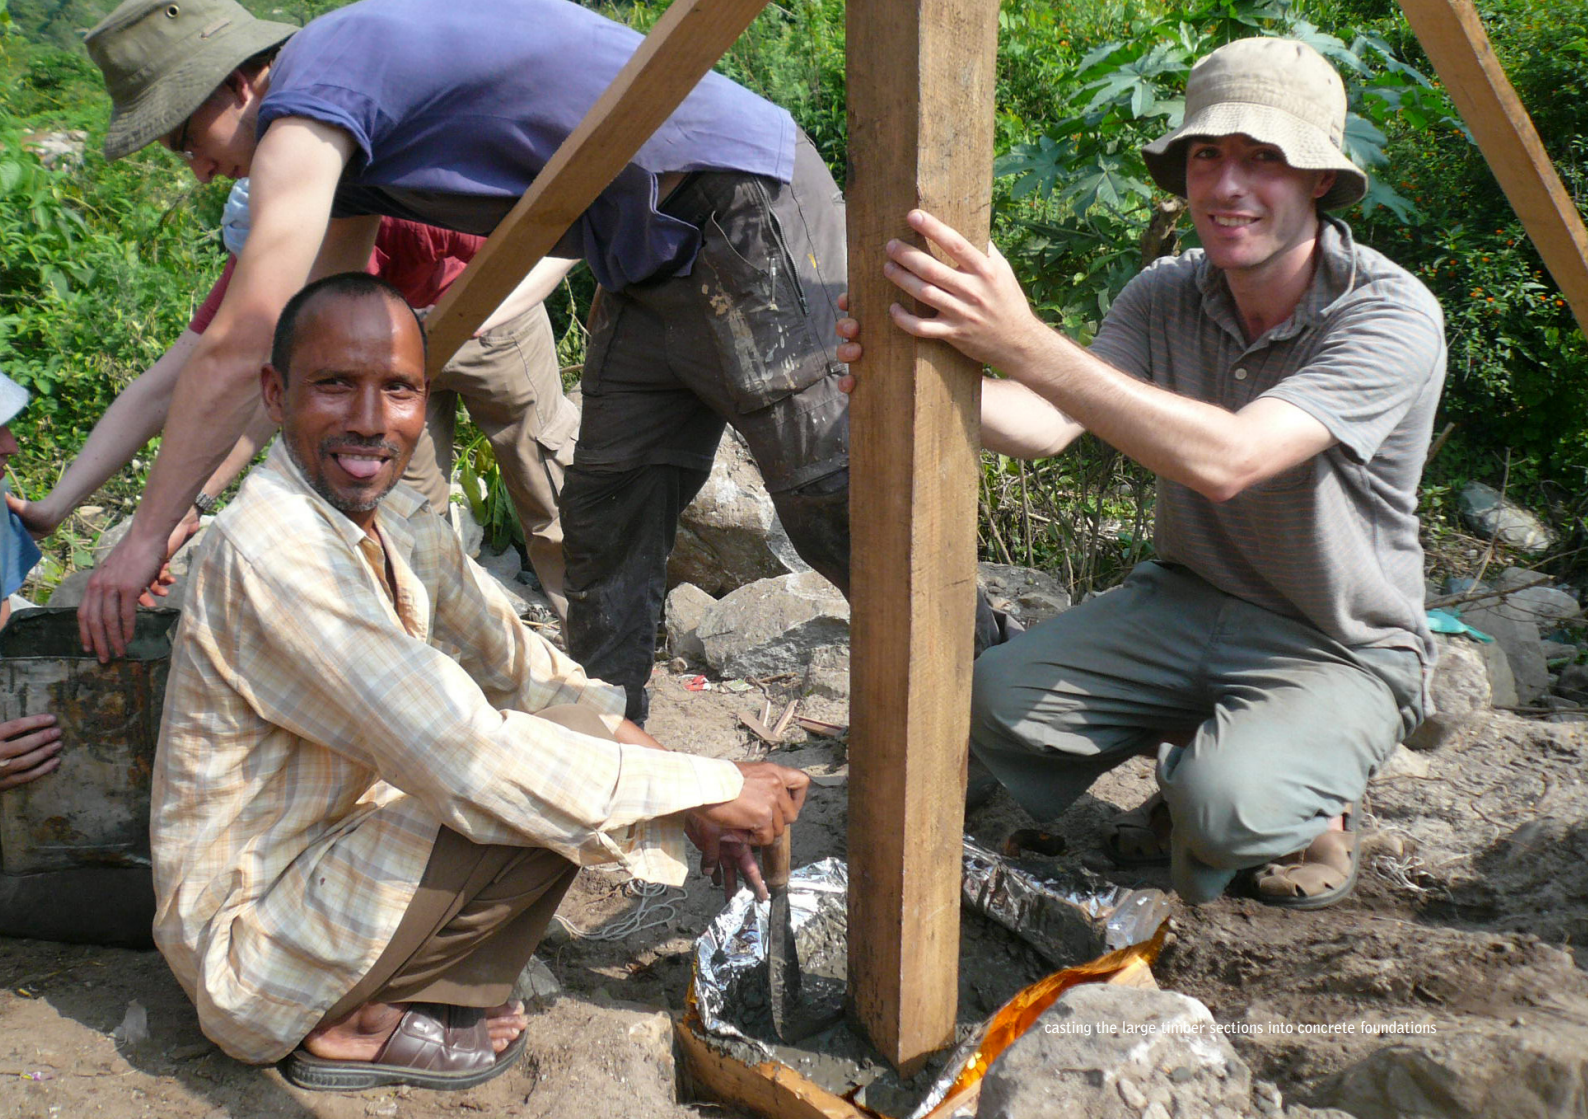
casting the large timber sections into concrete foundations

Two different sections of timber post were used: 75mm and 100mm. They were placed in a grid at 1.25m centres around the edge of the main structure and along the verandah. In addition, two posts were placed in the centre of the space. A simple plumb line was used to ensure their verticality.

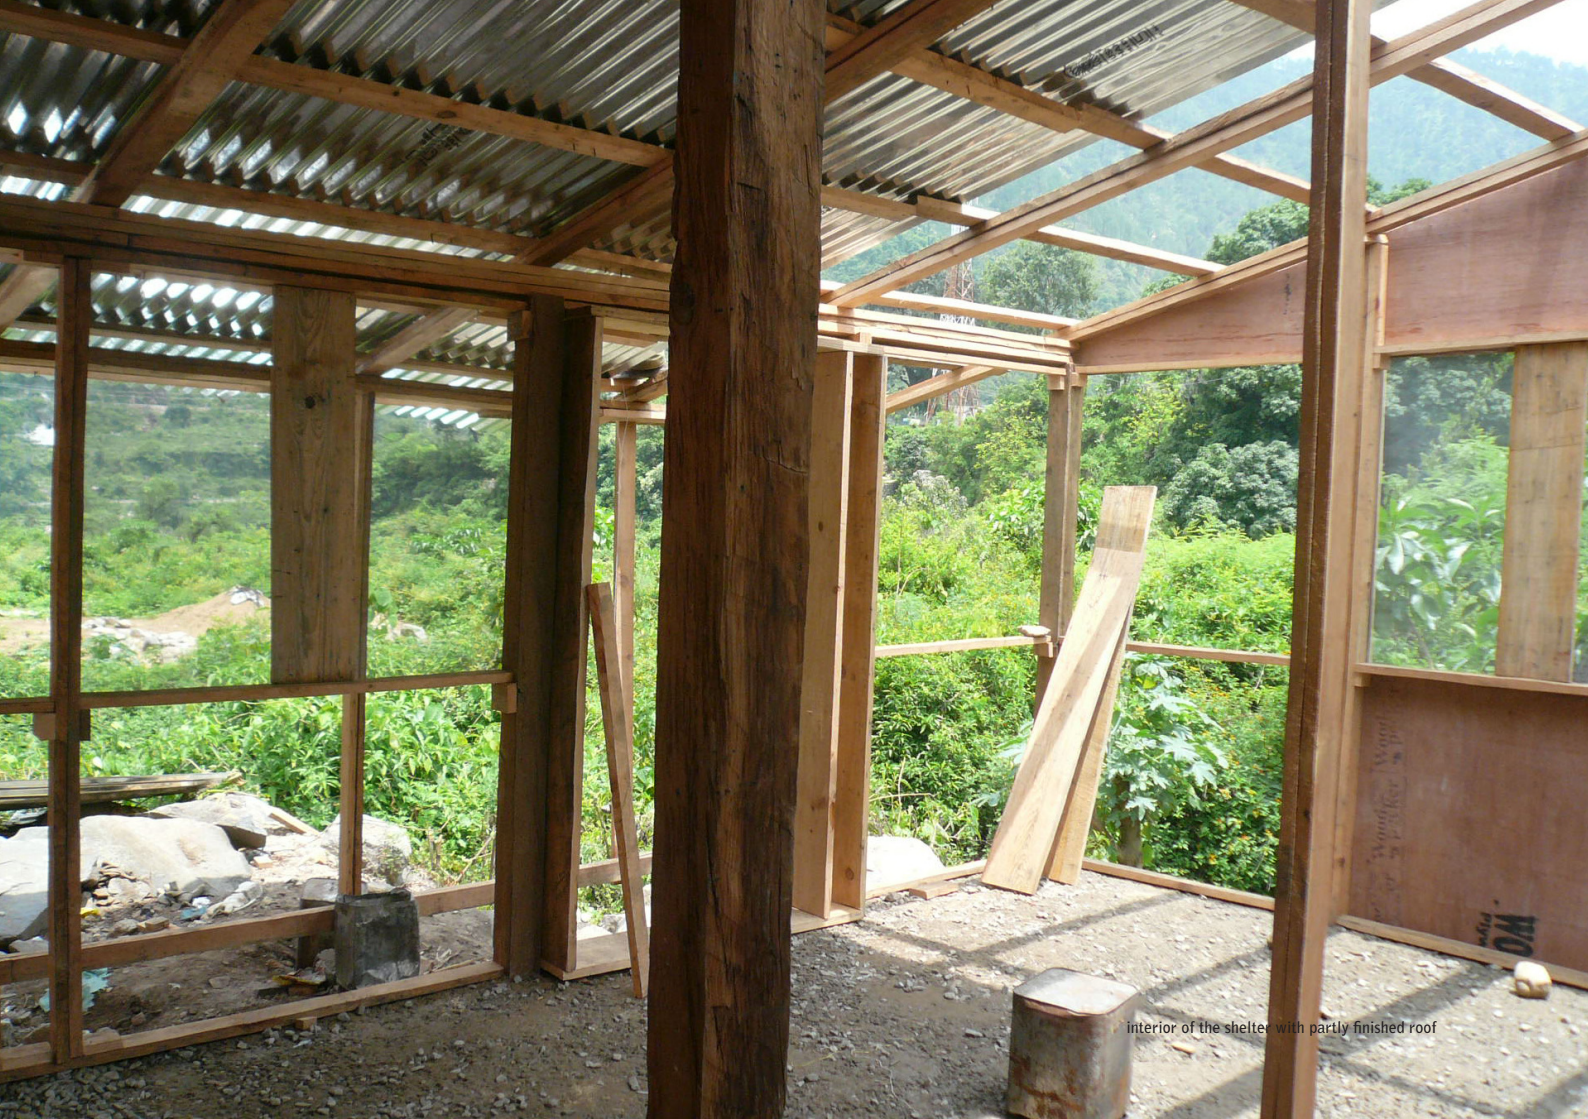
interior of the shelter with partly finished roof

The roof was constructed out of corrugated galvanised iron sheets that were nailed to the roof structure. They were laid with a large overhang at each of the four sides of the structure to protect the shelter from rain. In addition, each of the sheets overlapped the previous one considerably to prevent leakages through the roof.

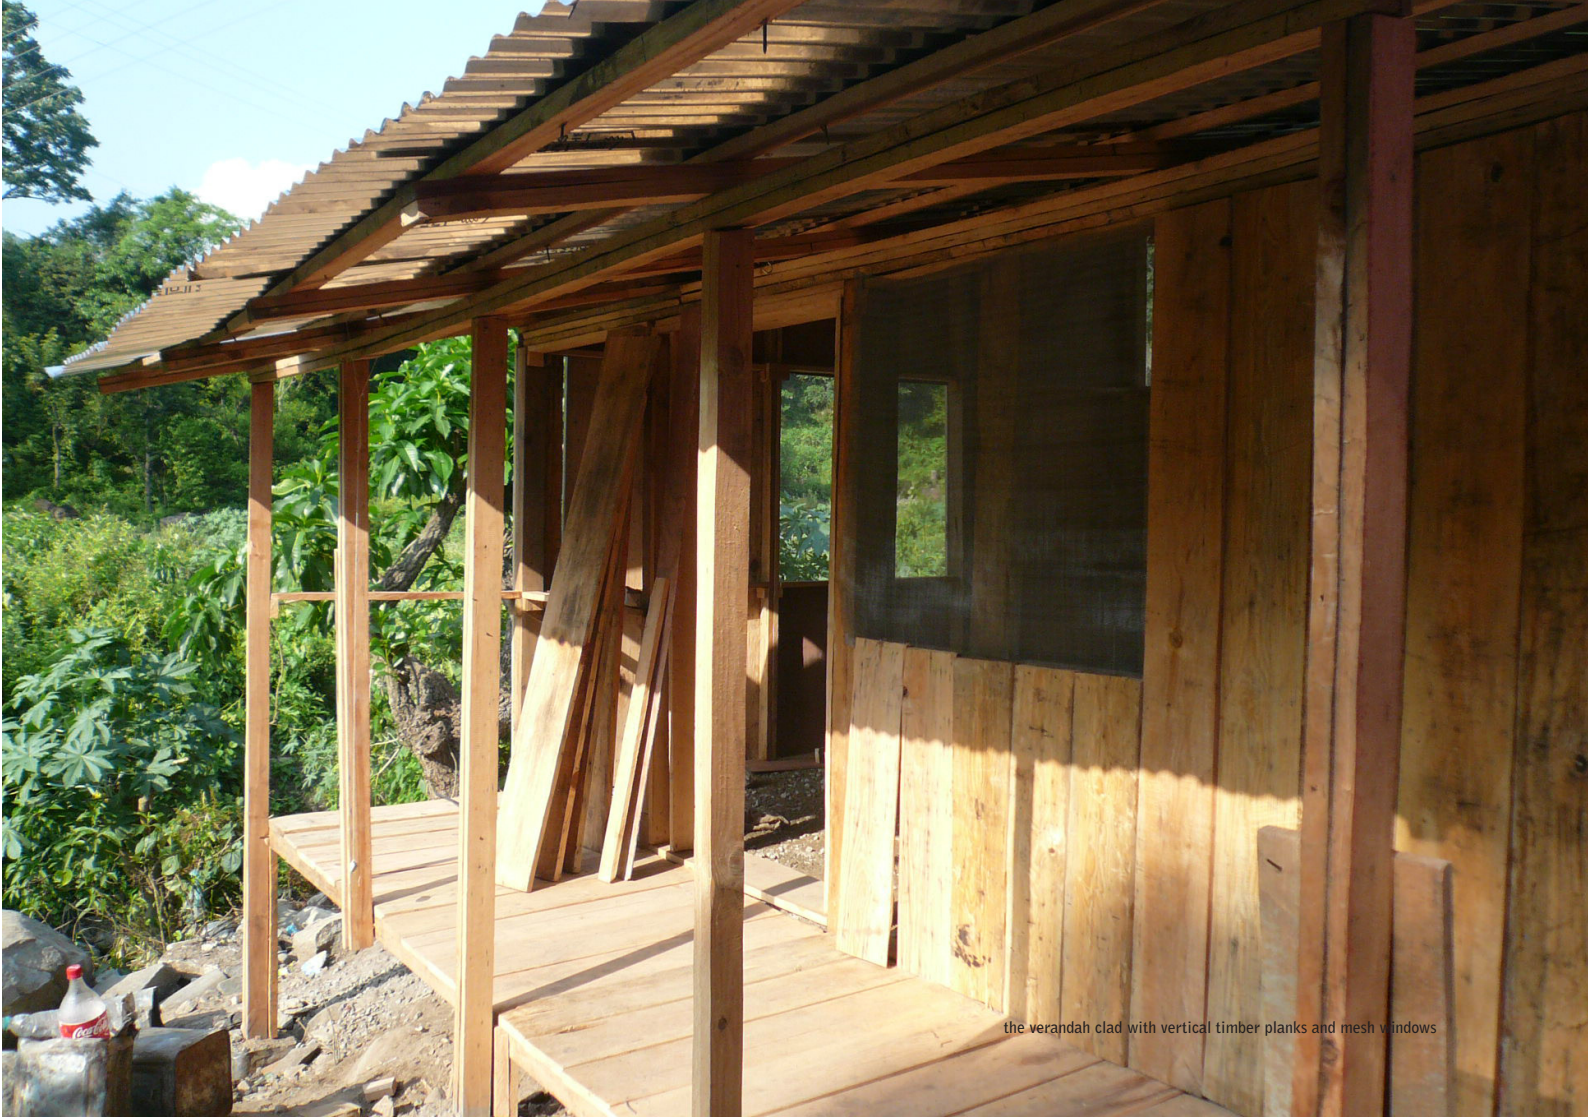
the verandah clad with vertical timber planks and mesh windows

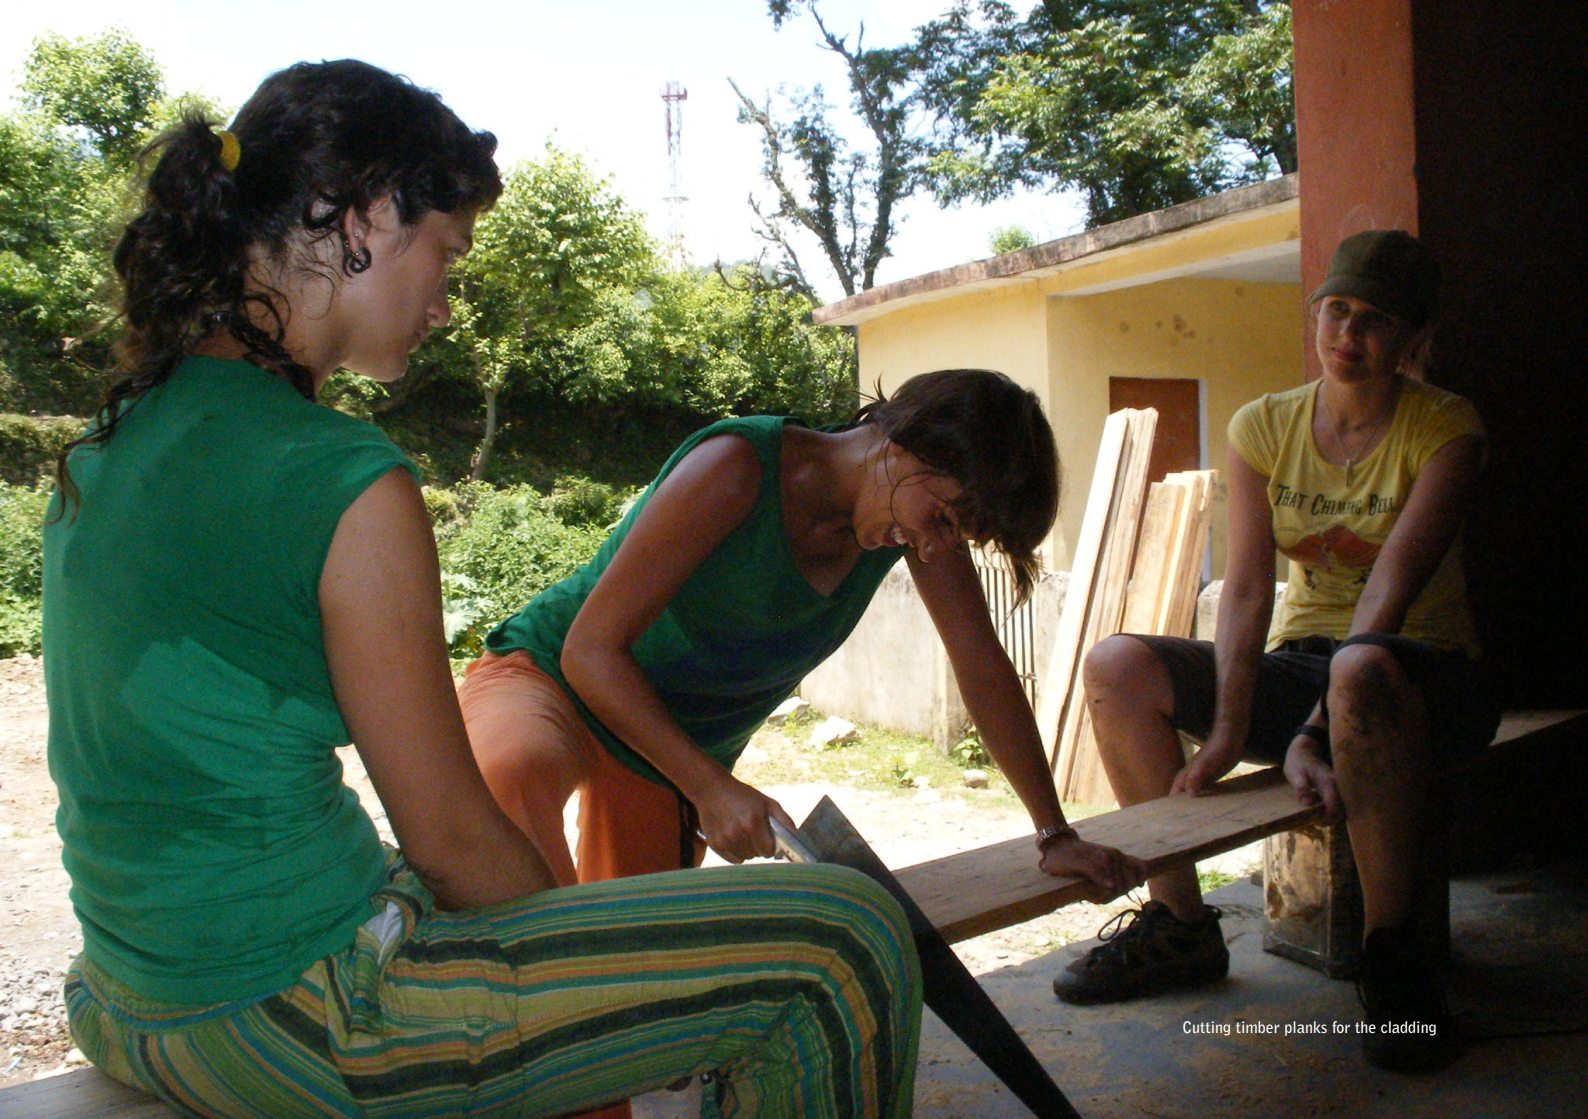
Cutting timber planks for the cladding

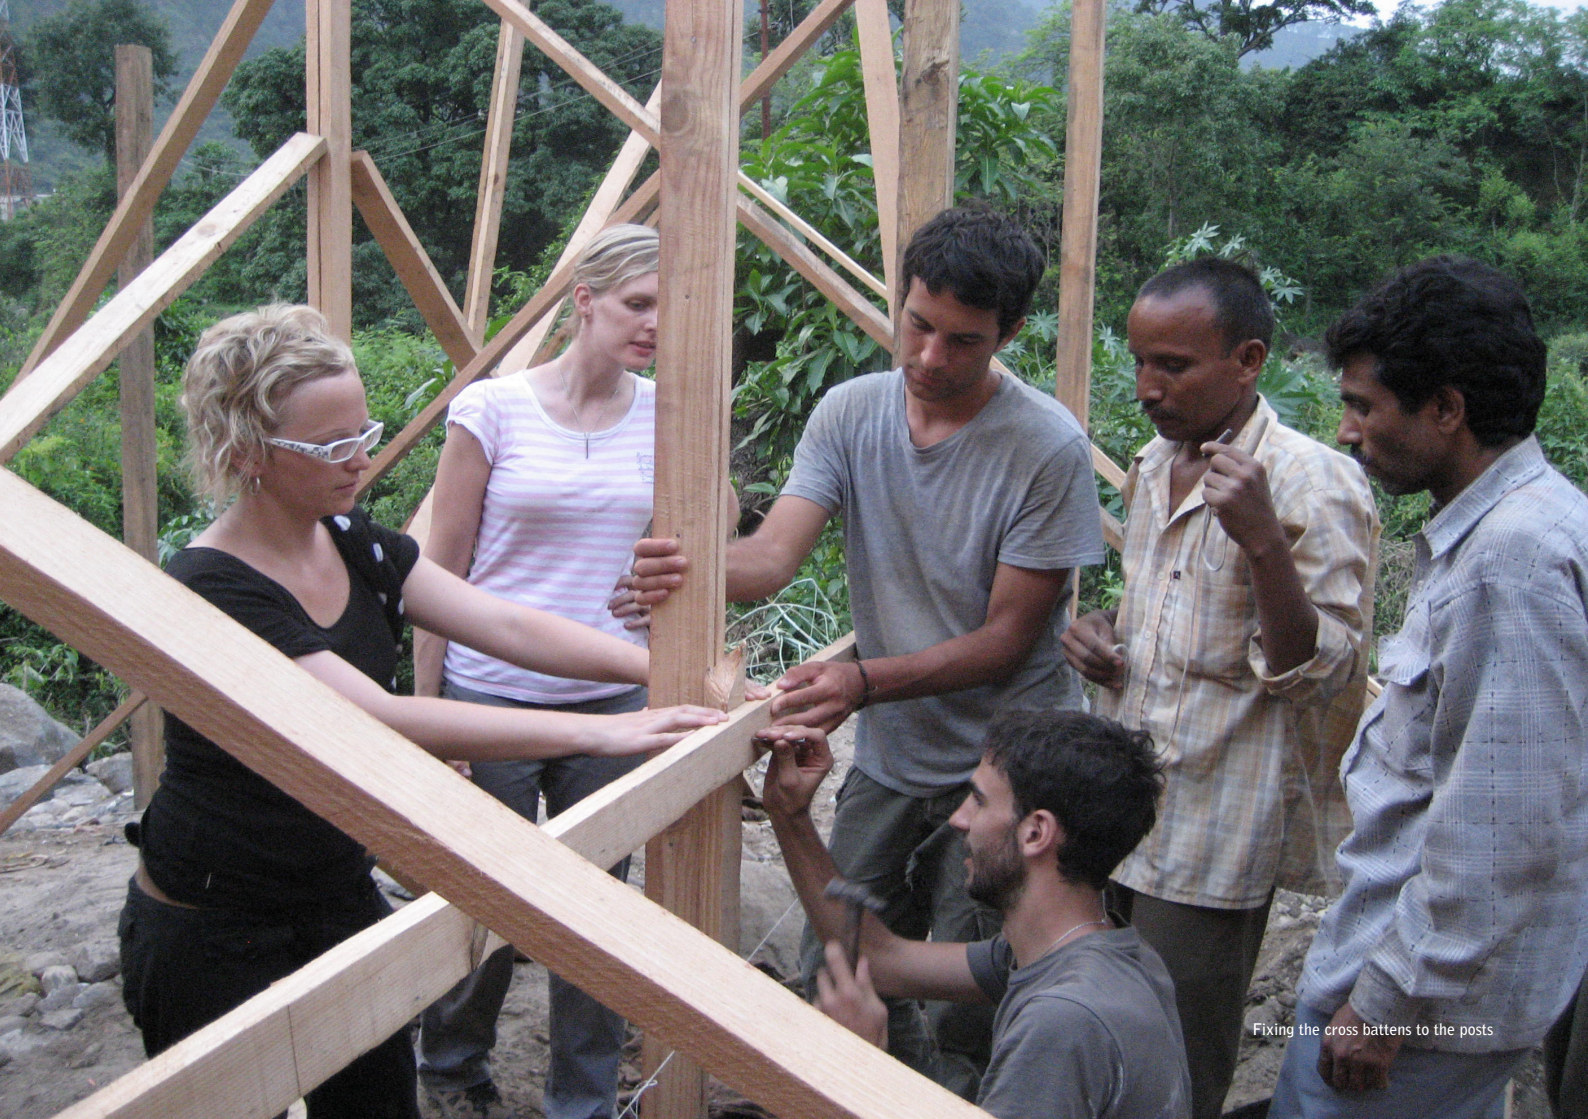
Fixing the cross battens to the posts

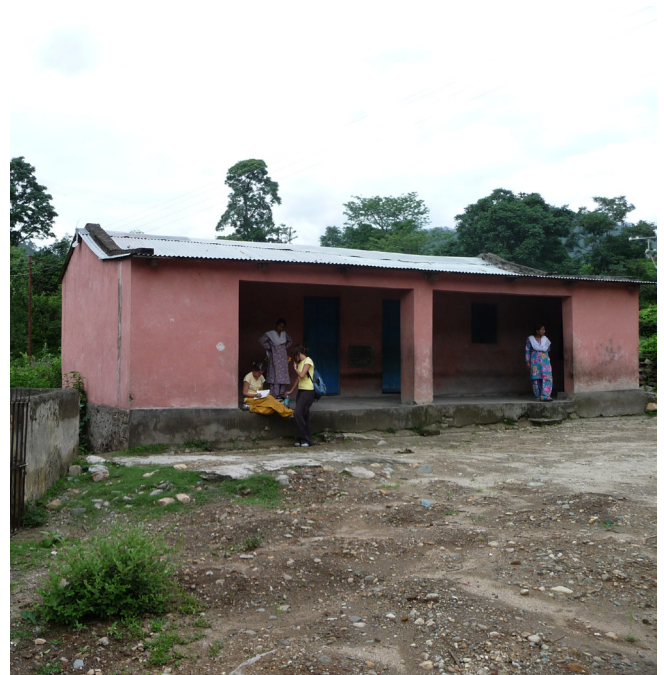
A survey of the school showed that the building needed building work to achieve this level of stability in event of an earthquake. Identified weak points were the corners, the column on the south facing side, and the openings in the walls for doors and windows. All of these points need retrofitting.

existing school building seen from across the yard

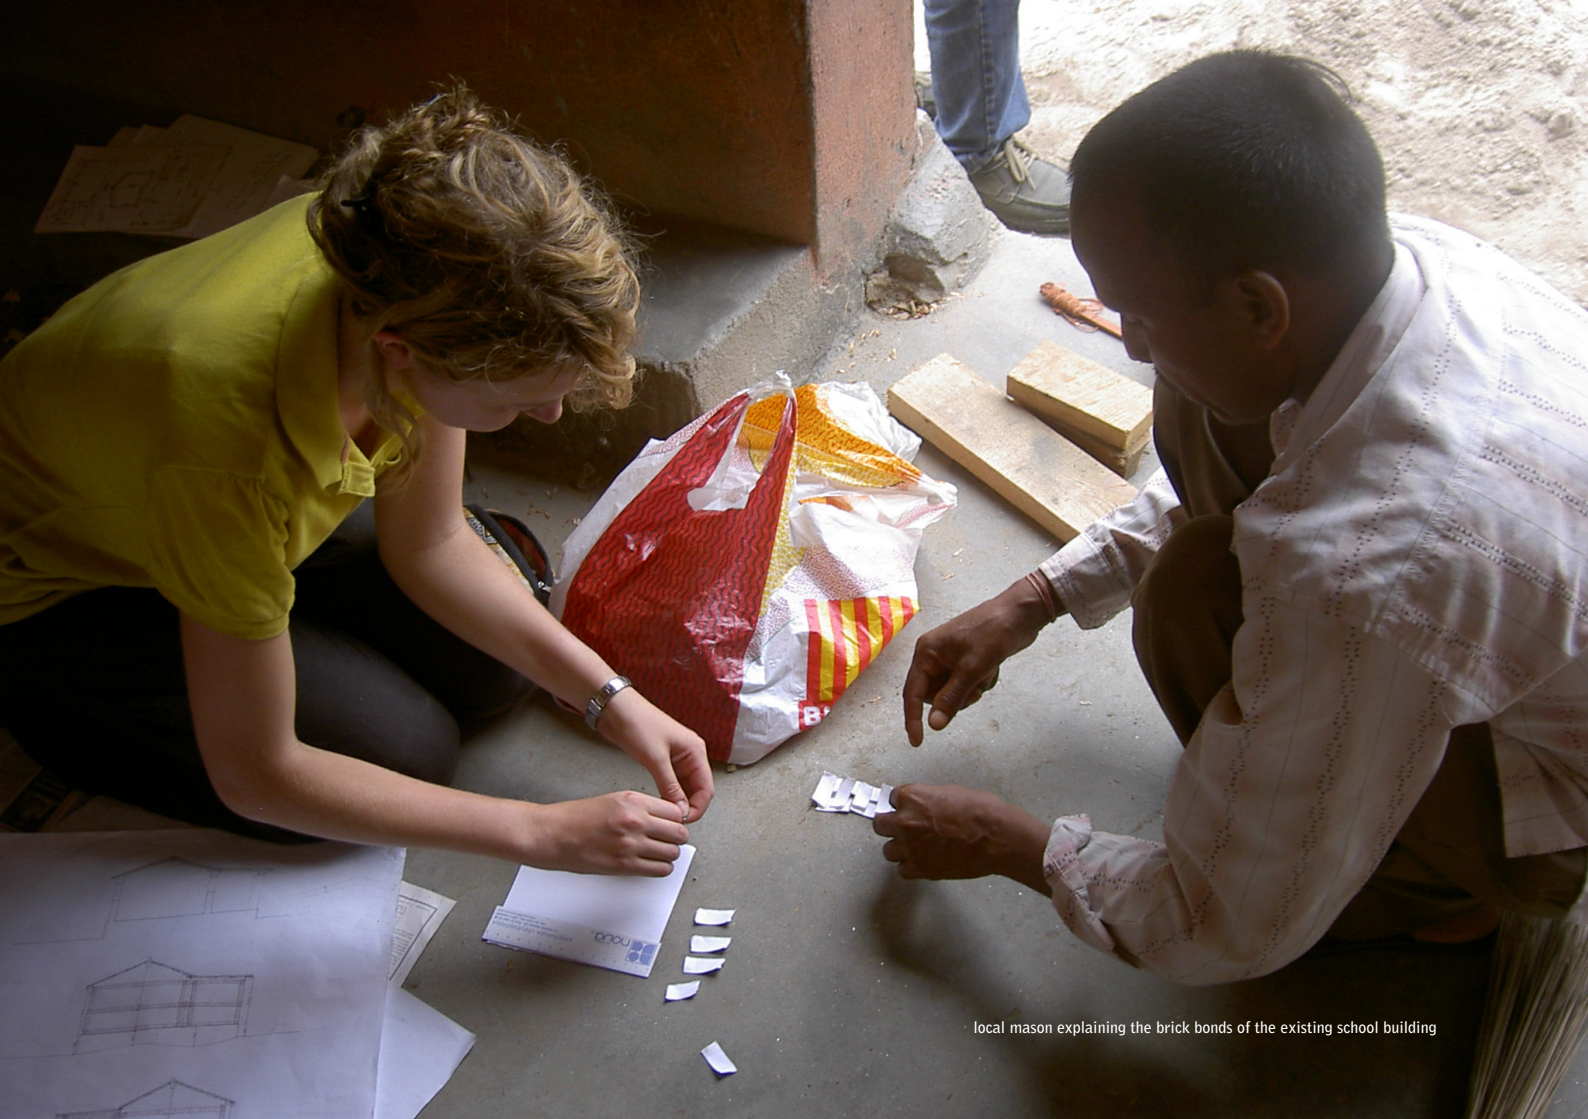
local mason explaining the brick bonds of the existing school building
